Limited Visual Dam Safety Inspections

Upper Helemano Reservoir

Oahu, Hawaii

May 2006

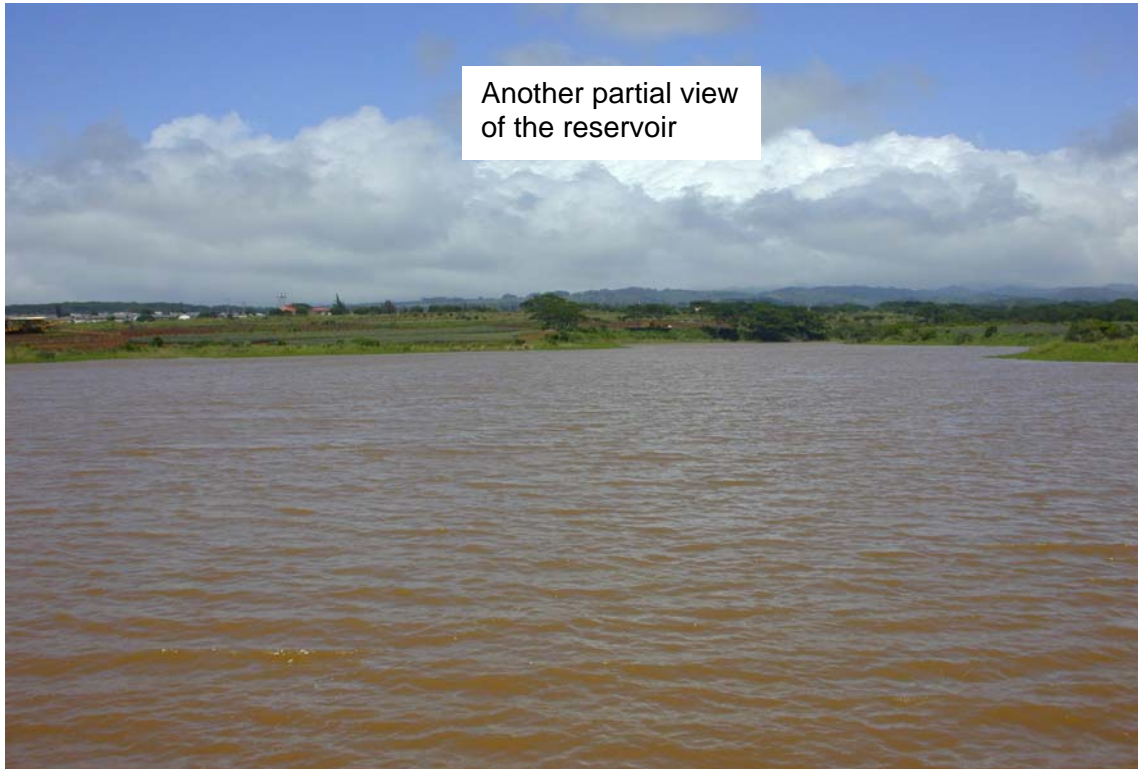
Another partial view
of the reservoir

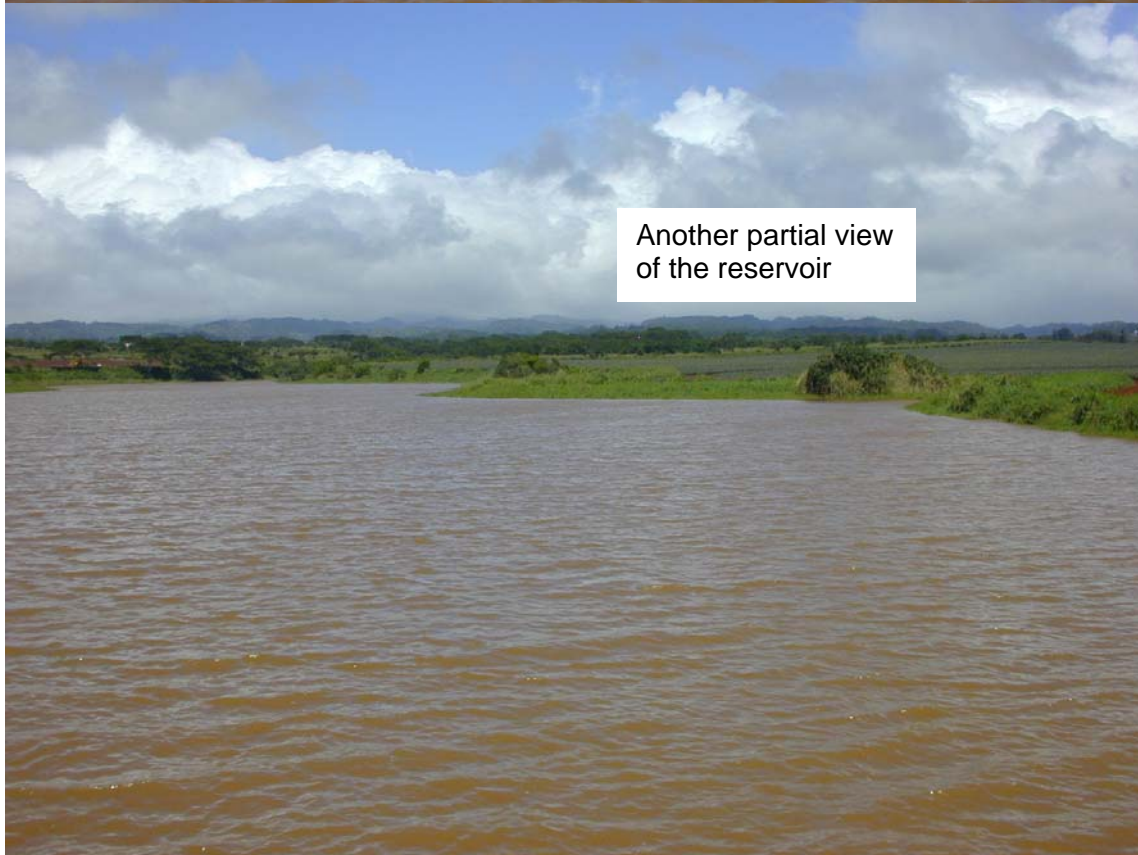
Another partial view
of the reservoir

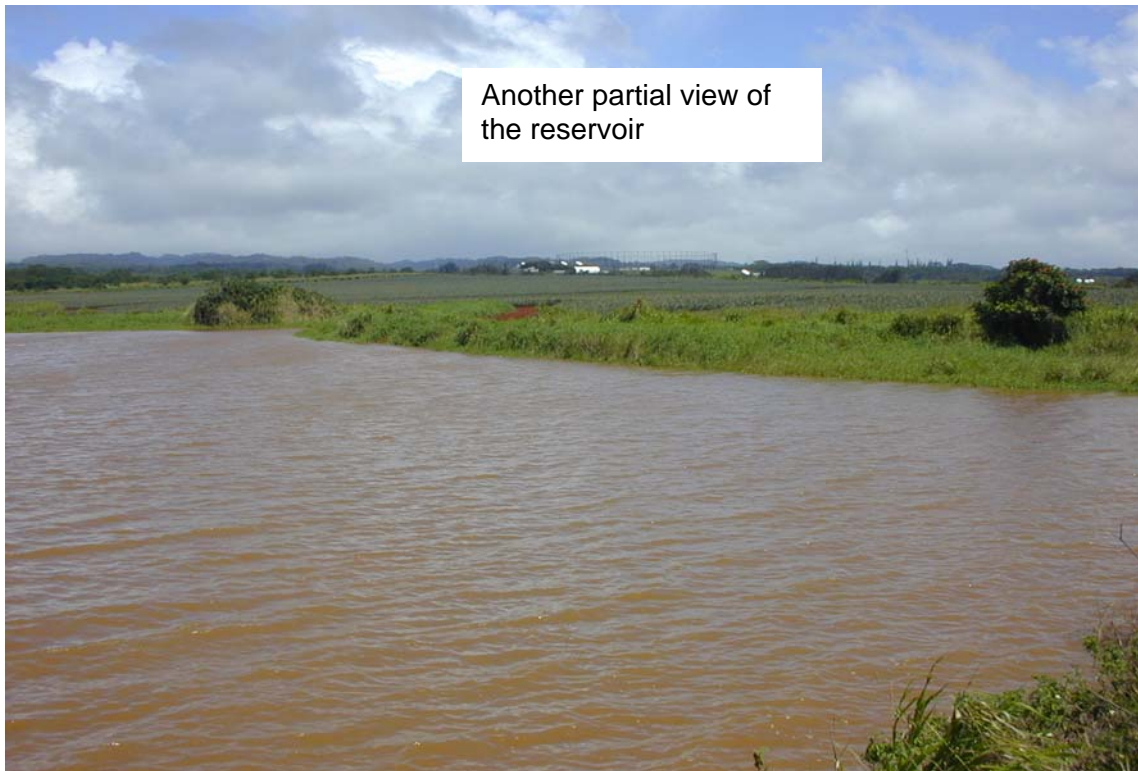
Another partial view of
the reservoir

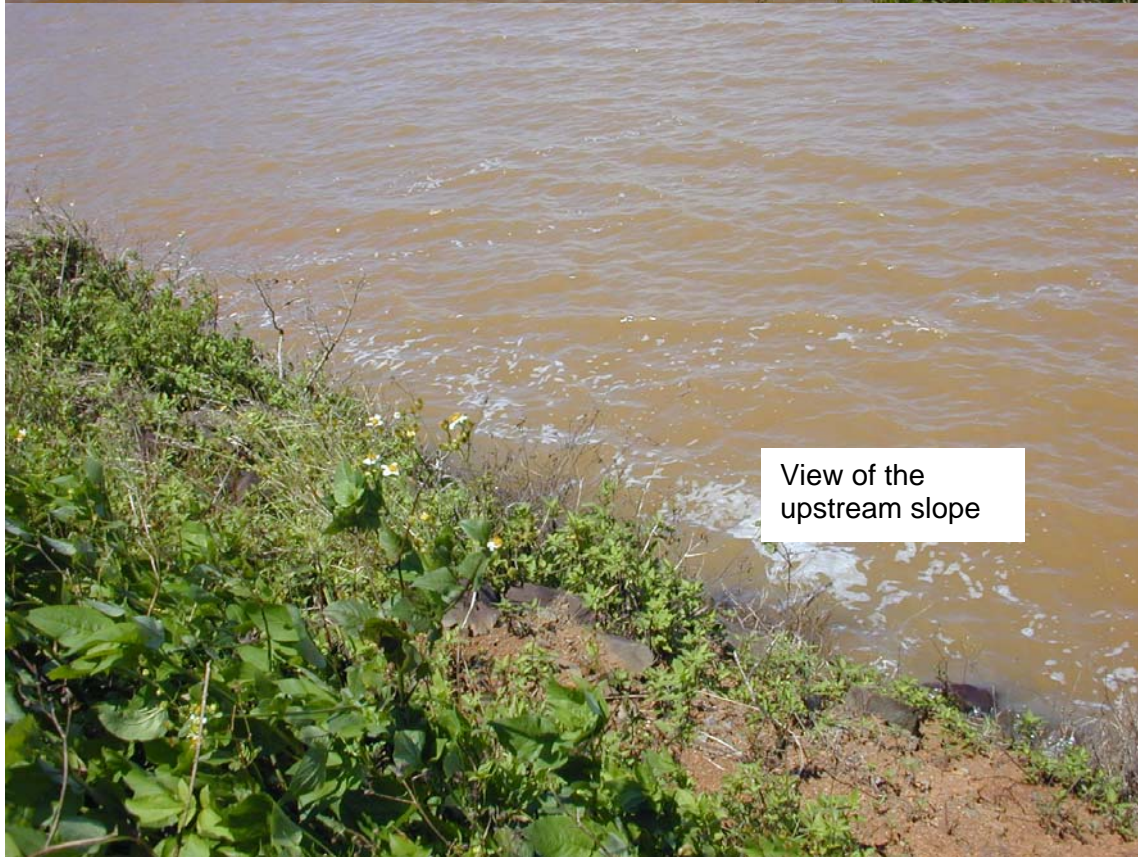
Rip rap rock slope protection was observed in some areas. Vegetation was observed growing between the rocks.

- a. The upstream slope was not fully inspected due to vegetative growth obscuring visual inspection.
- b. The upstream slope appeared to be in fair to poor condition and requires corrective action.
- c. The upstream slope was not visible due to high grass and bush vegetation. Clear high vegetation and maintain low to enable easy visual inspection.

View of the
upstream slope

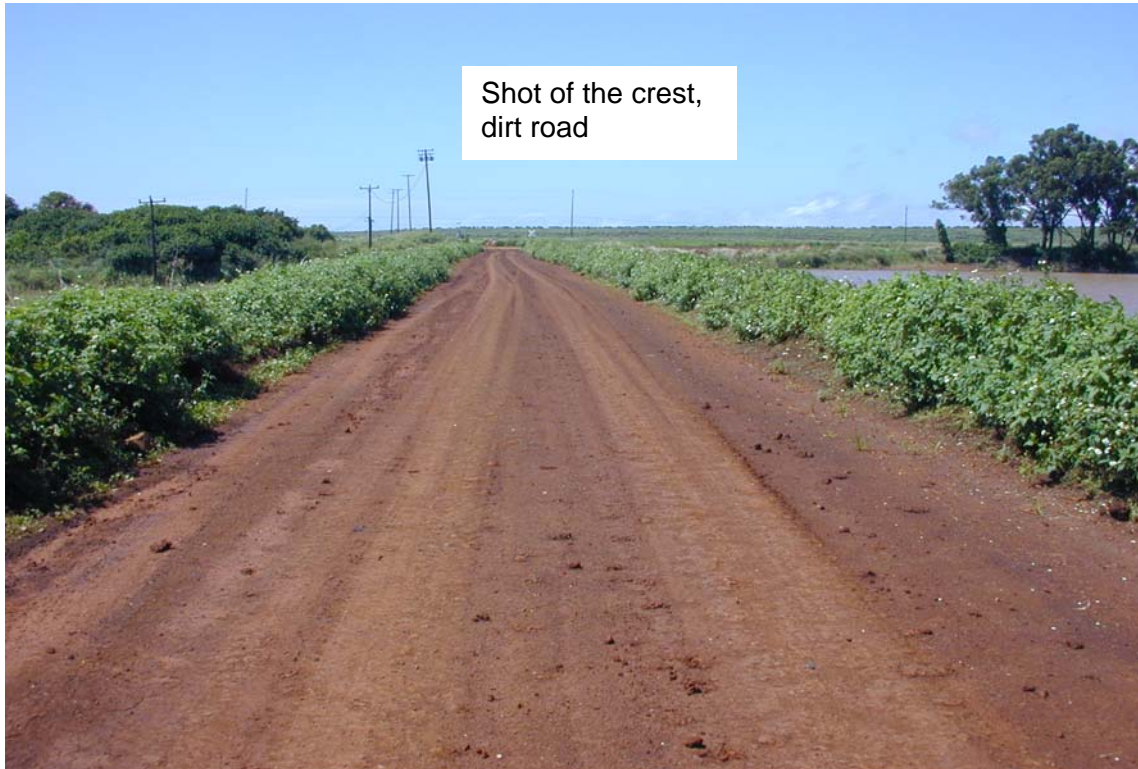
Vegetation was observed on the edges of the crest. These were primarily small woody vegetation and high grass.

- a. The dam crest appeared to be in fair condition and requires corrective action.
- b. Access along the crest was satisfactory.
- c. Portions of the crest were not visible due to high grass and bush vegetation. Clear high vegetation and maintain low to enable easy visual inspection.

Shot of the crest,
dirt road

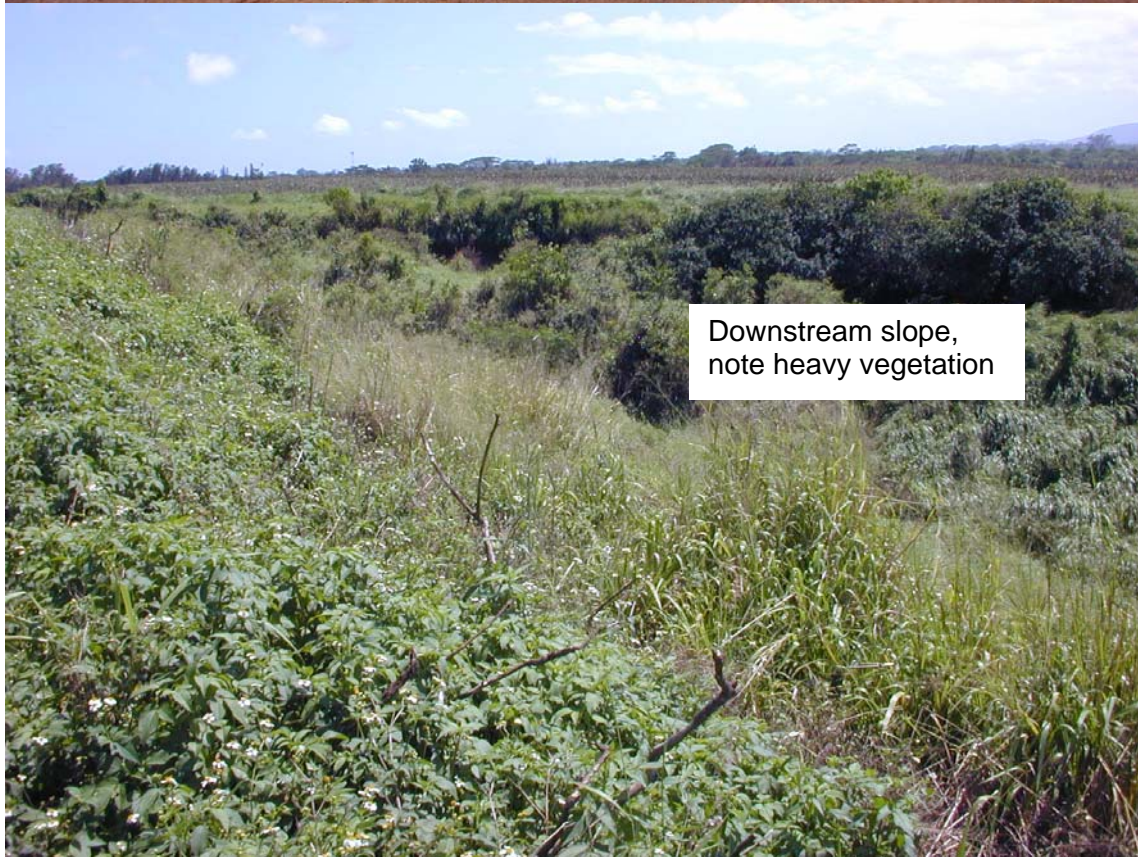
Vegetation was observed on the downstream slope. The majority of the vegetation was woody bushes and trees.

- a. The downstream slope was not fully inspected.
- b. The downstream slope appeared to be in fair to poor condition and requires corrective action.
- c. Tree(s) were observed on the downstream slope. Trees have been identified as the probably cause of piping failures, and can possibly cause severe damage to the embankment if they are uprooted during a high winds. Corrective action is required to remove the tree hazards from the dam. Acceptable remedies include removal of the tree and its root structure down to a 2" diameter and reconstructing the damaged embankment section. All repair work shall be accomplished as per the requirements of licensed geotechnical or structural engineer. Routinely monitor the damaged area for signs of settlement and seepage.
- d. The slope was very steep, around a 1 to 1 slope, further study is required to verify slope stability.

Downstream slope,
note heavy vegetation

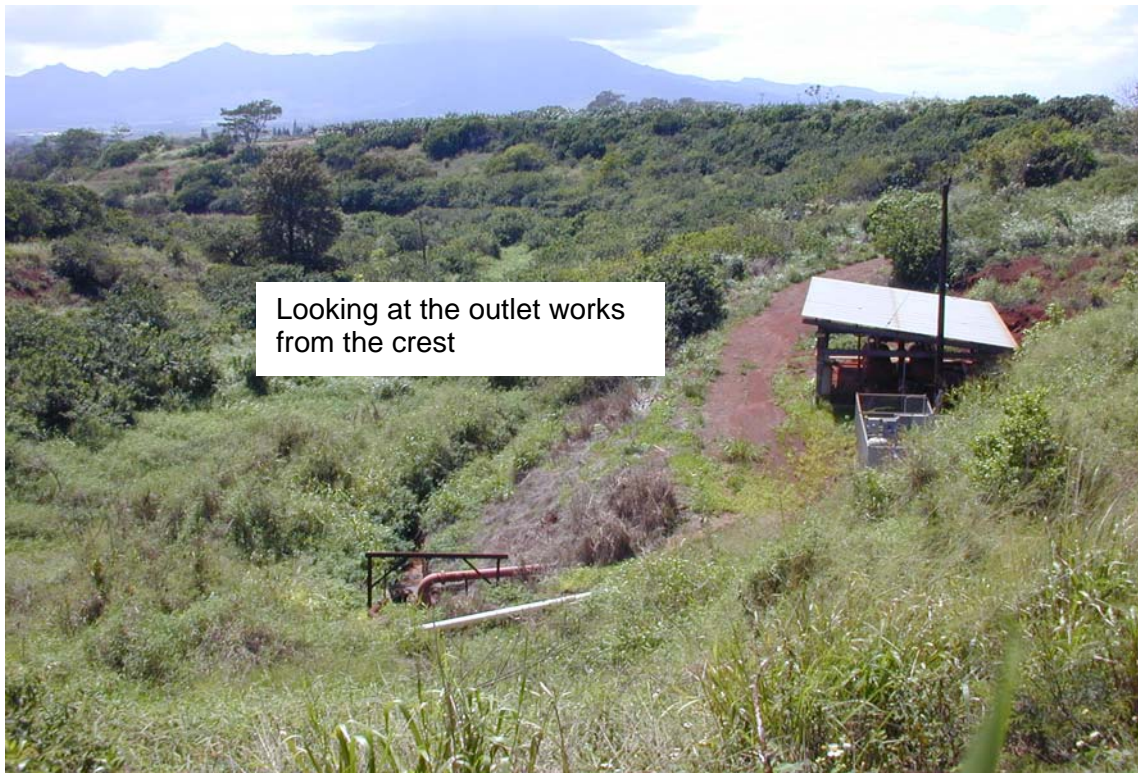
- a. The outlet works were not inspected.
- b. The outlet works were not tested.
- c. The outlet works appeared to be in satisfactory condition, no corrective actions are required at this time.

Looking at the outlet works from the crest

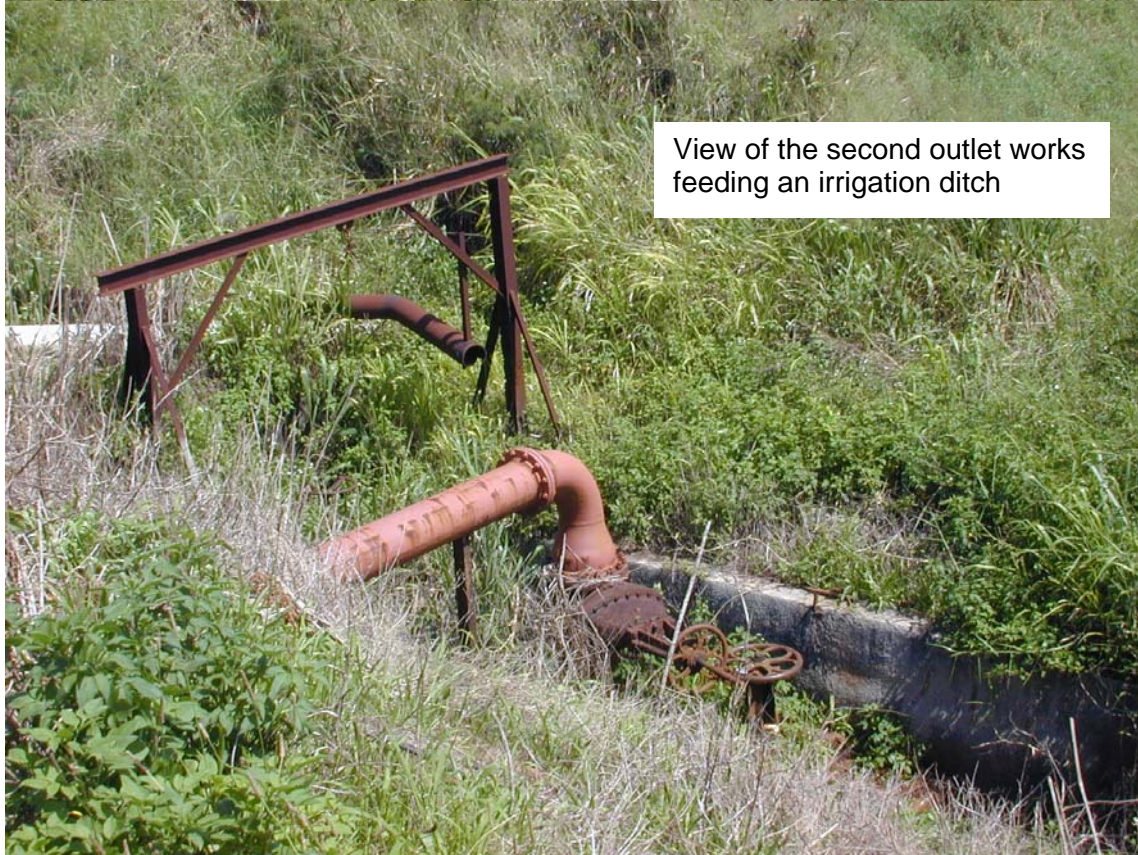
View of the second outlet works feeding an irrigation ditch
